Grand Strand Inspections

Property Inspection Report

**Property address: 123 Melody Lane
Mayberry USA**

Inspection date: Thursday, March 17, 2016

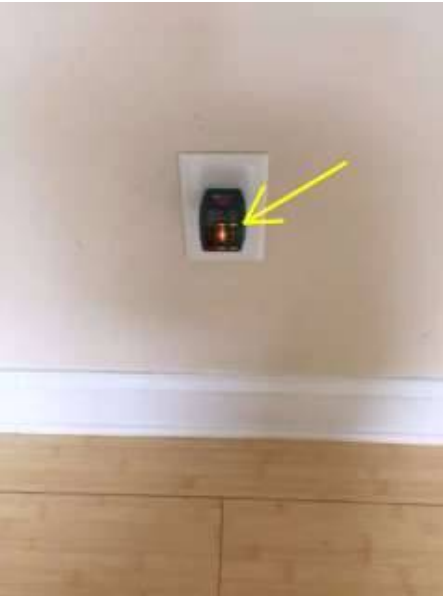
Photo 4-1

One or more electric receptacles were incorrectly wired with "false grounds" where the receptacle's ground screw is connected to the neutral or white wire in the circuit. Such receptacles may appear to be grounded when they aren't. This is a shock hazard, and can damage equipment plugged into such receptacles. Recommend that a qualified electrician repair as necessary. For more information, visit:

Photo 4-2
Open Ground - Inspected in both Living Room and Bonus / Guest Bedrooms.

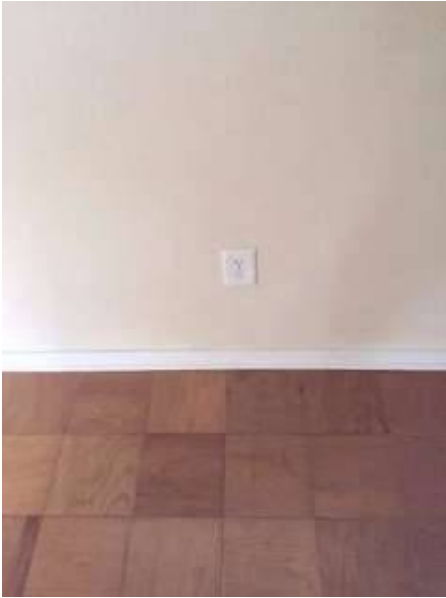
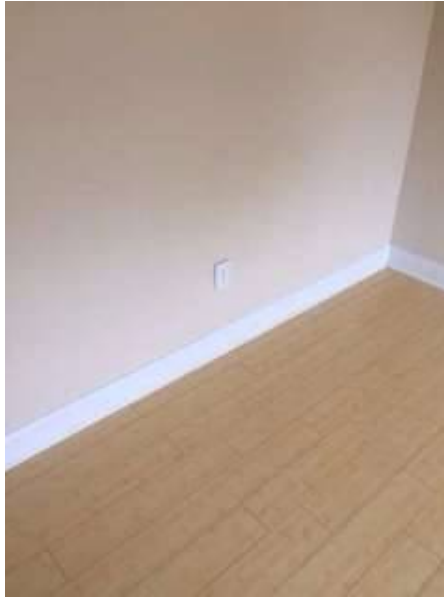
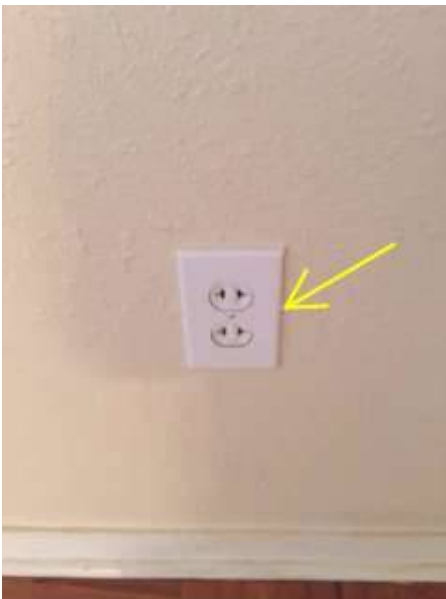
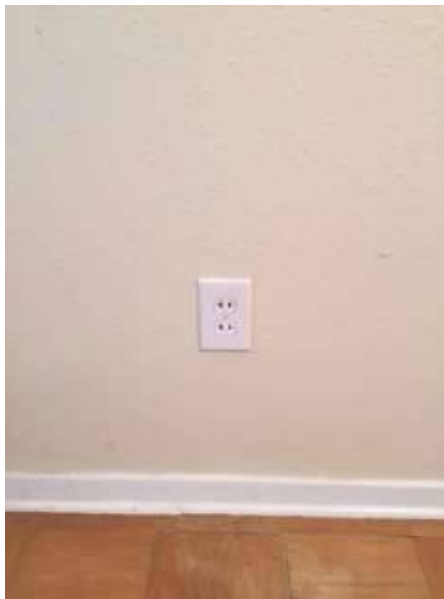
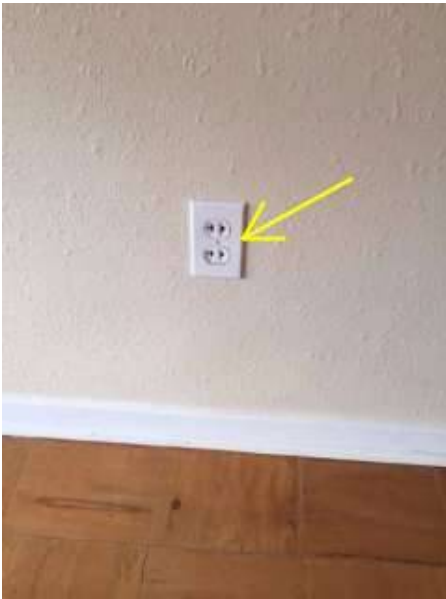
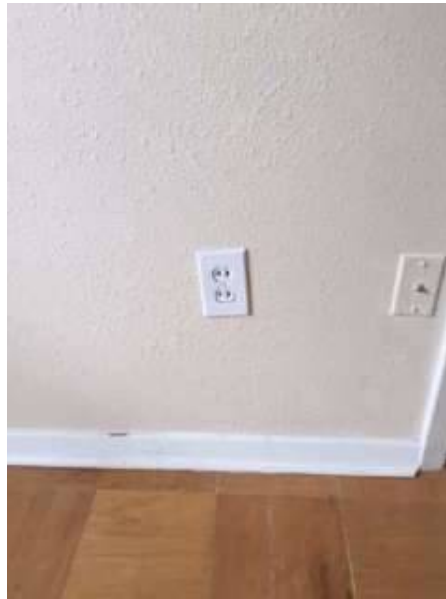
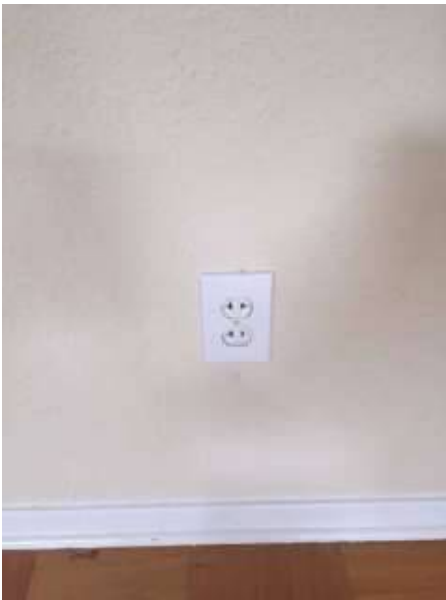
2-slot receptacles rather than 3-slot, grounded receptacles were installed in one or more areas. These do not have an equipment ground and are considered unsafe by today's standards. Appliances that require a ground should not be used with 2-slot receptacles. Examples of such appliances include computers and related hardware, refrigerators, freezers, portable air conditioners, clothes washers, aquarium pumps, and electrically operated gardening tools. The client should be aware of this limitation when planning use for various rooms, such as an office. Upgrading to grounded receptacles typically requires installing new wiring from the main

service panel or sub-panel to the receptacle(s), in addition to replacing the receptacle(s). Consult with a qualified electrician about upgrading to 3-wire, grounded circuits. These were located and inspected throughout the home.

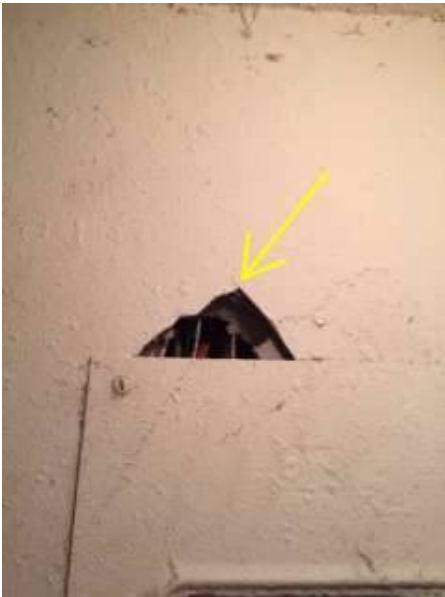
Views of Service Panel - Potential Double Tap which should be evaluated by a licensed professional - Outside of that appeared serviceable and in working order with minor wall damage at top of panel on wall.

Photo 6-1
Opening in wall top of service panel.

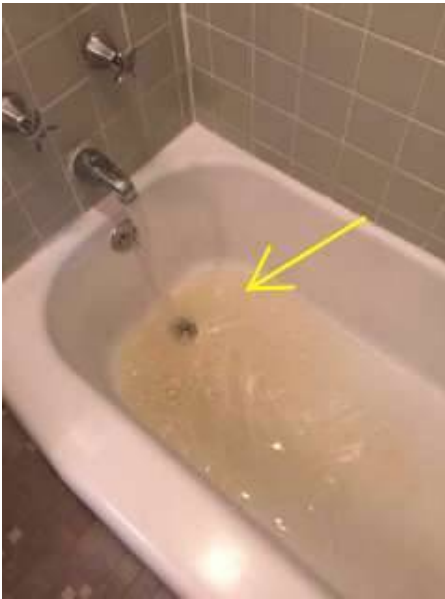
The main water service pipe material was made of galvanized steel. Based on the age of the building, the apparent age of the pipe and/or the low-flow condition of the water supply system, this service pipe may have significant corrosion or rust on the inside and need replacing. Replacing the service pipe can significantly increase flow to the water supply pipes. Recommend consulting with a qualified plumber about replacing the main service pipe. Note that this can be an expensive repair since excavation is typically required.

Photo 8-1
Discoloration of water supply.

Water was discolored when bathtubs or sinks were filled, or when showers were operated. This can be caused by water stagnating in water supply pipes, rust accumulating in pipes or in the water heater, or sediment being present in the water supply. Recommend flushing the water supply piping and the water heater. If that fails to resolve the issue, then have a qualified plumber evaluate and repair as necessary.

Have contacted the HOA/Property Management for confirmation. Additionally, have asked what corrective measures are in place or pending based upon other similar properties being affected by the same or similar issues.

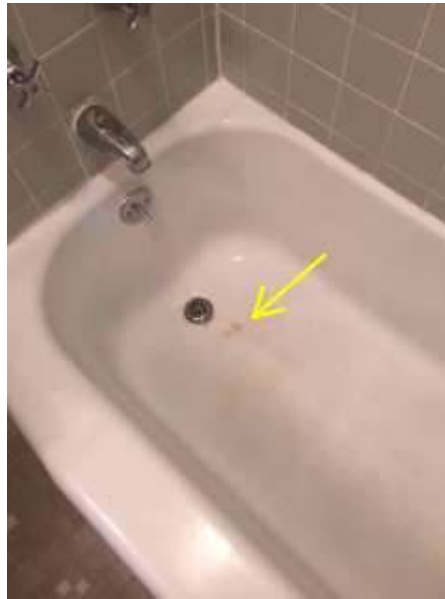
Photo 8-2
Sediment in water supply.

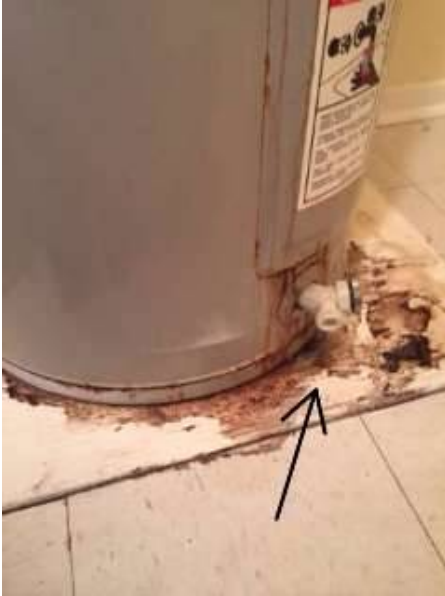
Photo 11-1

Water stains were found below or near the water heater. This may be a sign that the water heater is failing, or be a sign of a past leak. Consult with the property owner about this and review any disclosure statements. Depending on what information is available about the stains, a qualified plumber should evaluate and make repairs or replace the water heater as necessary. No immediate evidence of leaking during the inspection however stains were apparent and no drip pan was installed at the base of the appliance.

Apparent moisture damage at base of water heater no drip pan or temperature relief pipe in place.

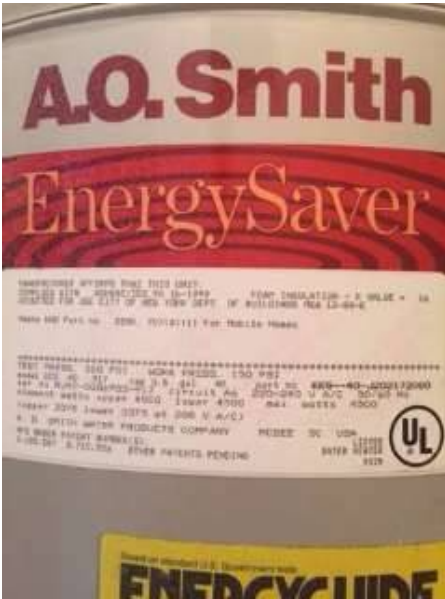
The estimated useful life for most water heaters is 8-12 years. This water heater appeared to be beyond this age and/or its useful lifespan and may need replacing at any time. Recommend budgeting for a replacement in the near future, or considering replacement now before any leaks occur. The client should be aware that significant flooding can occur if the water heater fails. If not replaced now, consider having a qualified person install a catch pan and drain or a water alarm to help prevent damage if water does leak.

Manufacture date of September 1997

Photo 12-1
Manufacturers details Electric Water Heater. September 1997

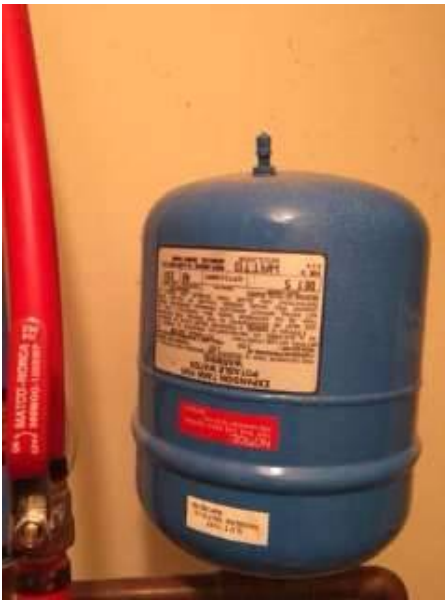
No temperature-pressure relief valve was installed on the water heater tank. This is a potential safety hazard due to the risk of explosion. A qualified plumber should install a temperature-pressure relief valve and drain line per standard building practices. Expansion tank installed and appeared serviceable at the time of the inspection.

Photo 13-1
Expansion Tank - Water Heater.

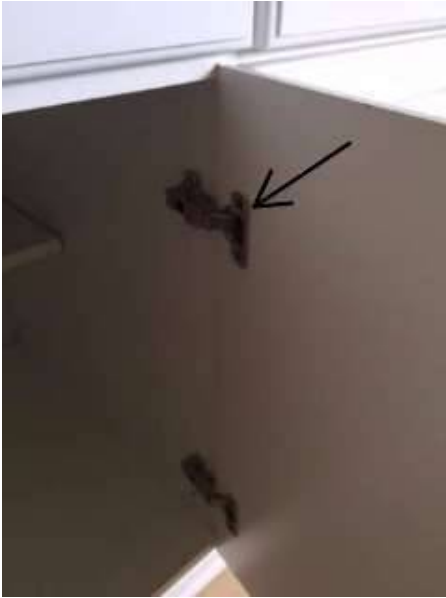
Minor adjustment to cabinet door.

Photo 16-1
Hinge Adjustment in Kitchen.

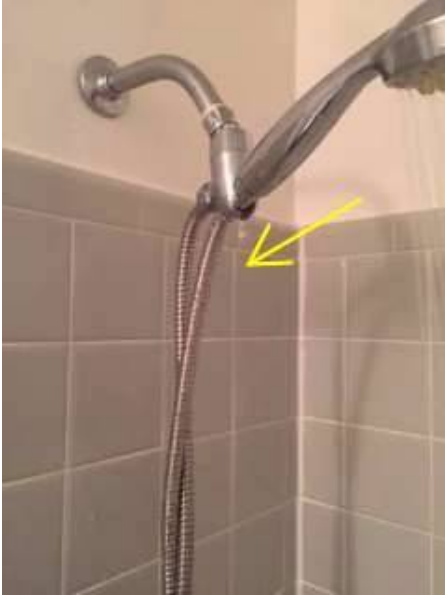
Photo 18-1

After market shower head installed and appeared to leak while being turned on during the inspection.

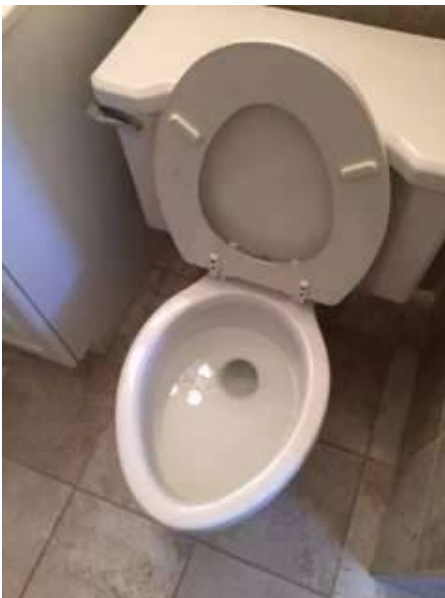
Photo 19-1

The toilet at location(s) #B and/or Master ran water continuously or didn't shut off after being flushed, and water leaked from the tank into the bowl. Significant amounts of water can be lost through such leaks. If this system uses a septic system, the septic system can be overloaded and cause significant and potentially expensive damage. A qualified person should repair or replace components as necessary.

Toilet in master bath would not end cycle adjustment needed and turned water off for conservation.

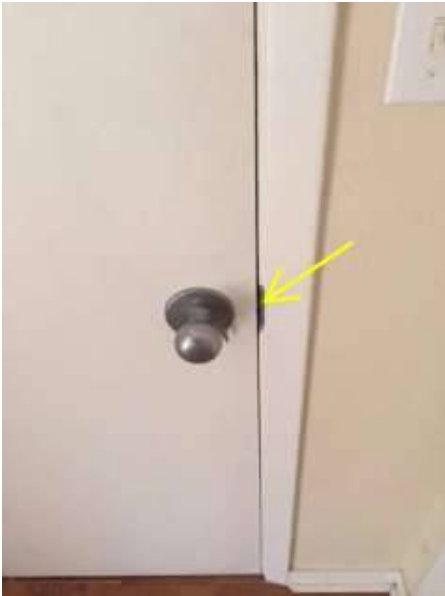
Photo 20-1

One or more interior doors wouldn't latch or were difficult to latch. Recommend that a qualified person repair as necessary. For example, by adjusting latch plates or locksets.

Not latching locking properly - Guest Bedroom.

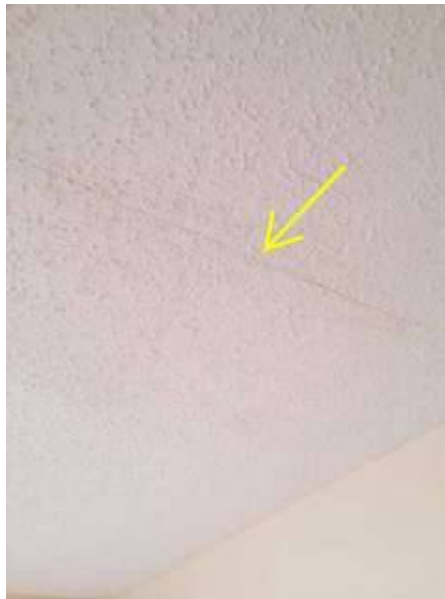
Photo X-8
Minor Tape Separation in Ceiling.

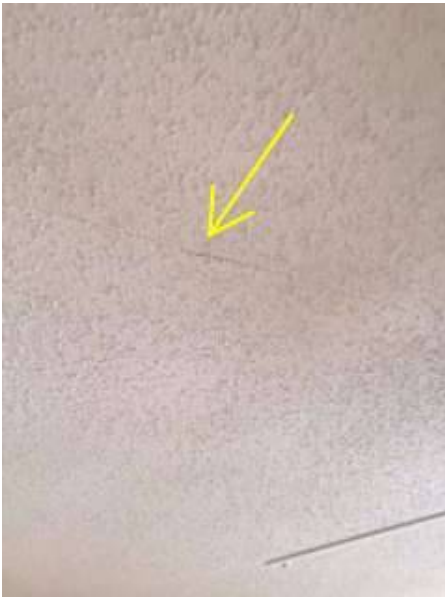
Photo X-9
Minor Tape Separation in Ceiling.

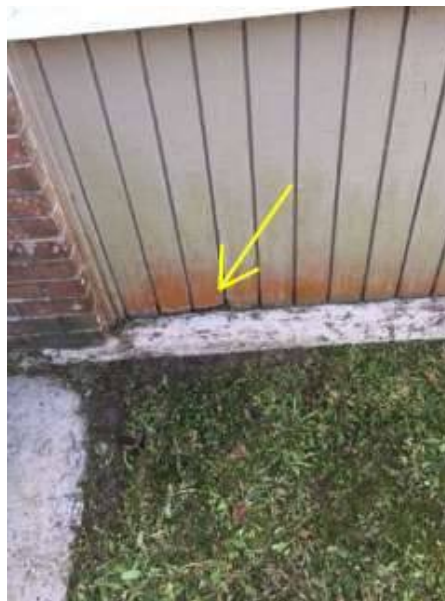
Photo X-12
Evident wood decay at base of exterior wall covering at screened porch.

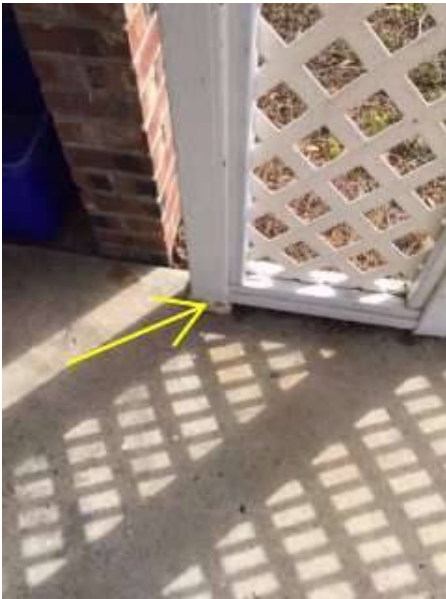
Photo X-13
Minor wood decay at lattice base in carport.

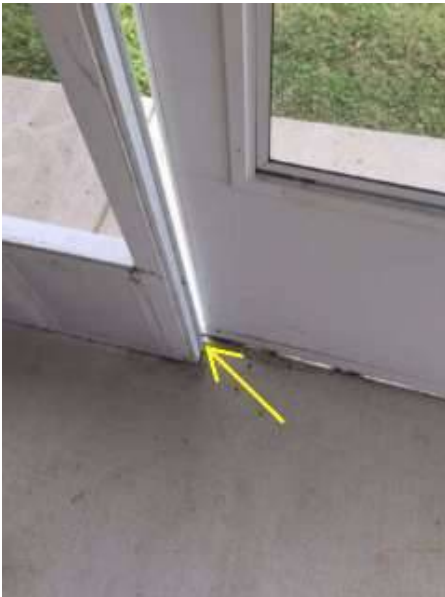
Photo X-21
Minor adjustment of rear patio door.

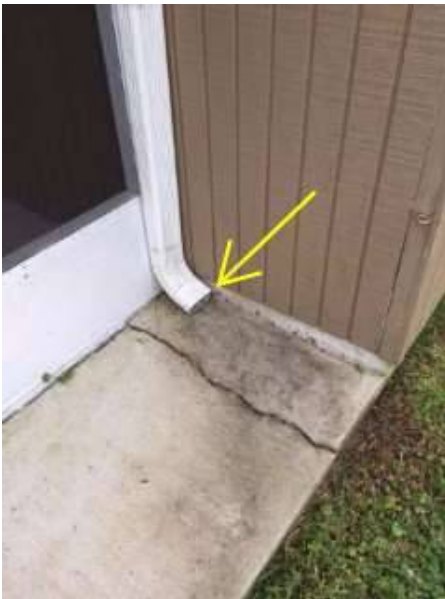
Photo X-23
Downspout should be extended beyond concrete.

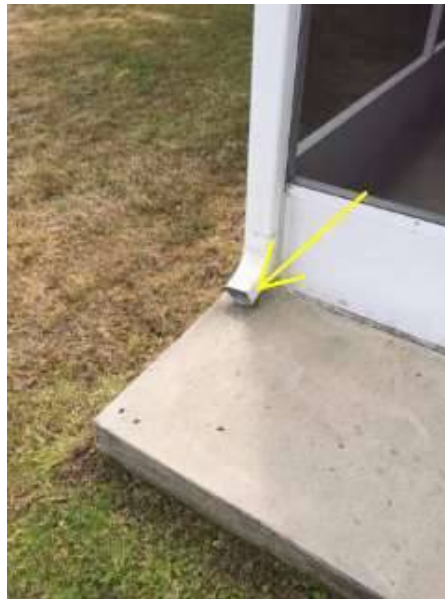
Photo X-24
Downspout should be extended beyond concrete.

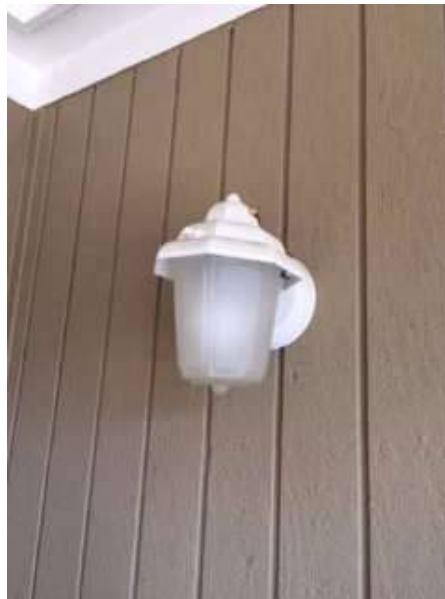
Photo X-32
Front light not operational - bulb replacement or repair.
