Grand Strand Inspections

Property Inspection Report

**Property address: 123 Melody Lane
Mayberry USA**

Inspection date: Thursday, March 17, 2016

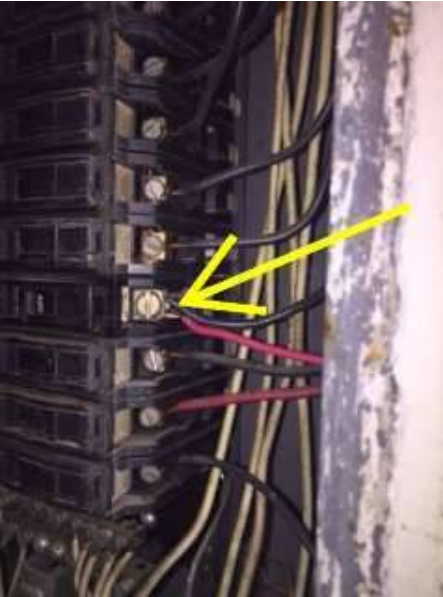
One or more circuit breakers in panel(s) #A were "double tapped," where two or more wires were installed in the breaker's lug. Most breakers are designed for only one wire to be connected. This is a safety hazard since the lug bolt can tighten securely against one wire but leave other(s) loose. Arcing, sparks and fires can result. Recommend that a qualified electrician repair as necessary. For more information, visit:

Potential Double Tap - Please consult with a licensed professional.

Photo 3-1
Suspected double tap inside service panel.

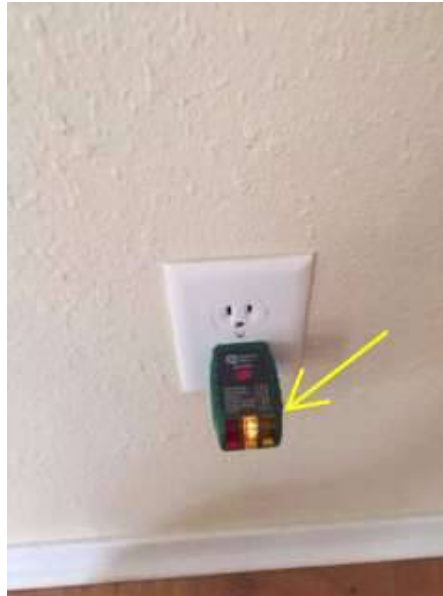
One or more electric receptacles were incorrectly wired with "false grounds" where the receptacle's ground screw is connected to the neutral or white wire in the circuit. Such receptacles may appear to be grounded when they aren't. This is a shock hazard, and can damage equipment plugged into such receptacles. Recommend that a qualified electrician repair as necessary. For more information, visit:

Photo 4-2
Open Ground - Inspected in both Living Room and Bonus / Guest Bedrooms.

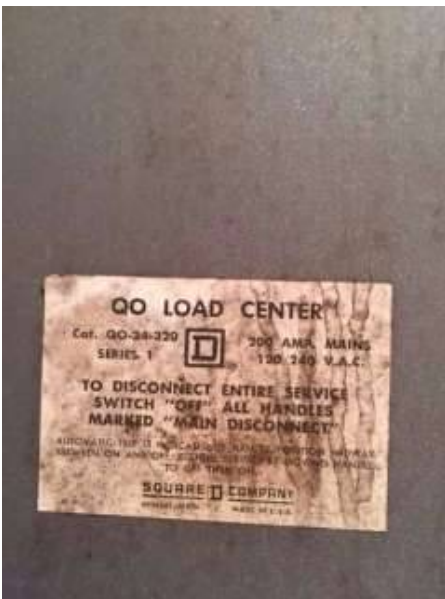
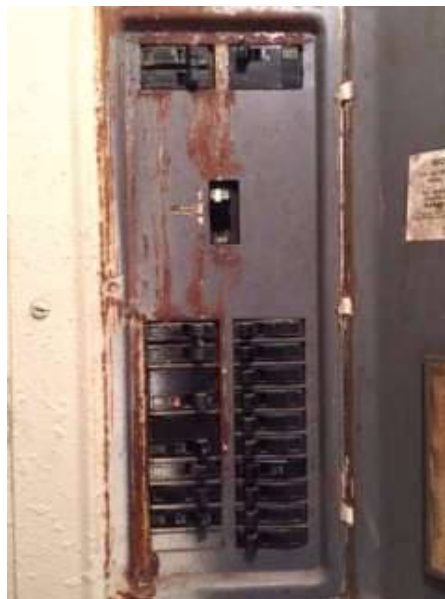
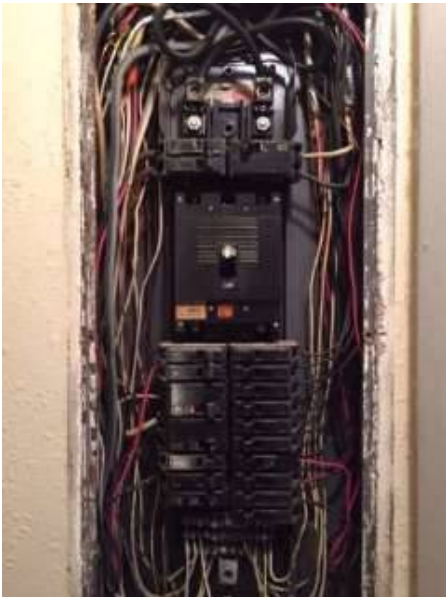
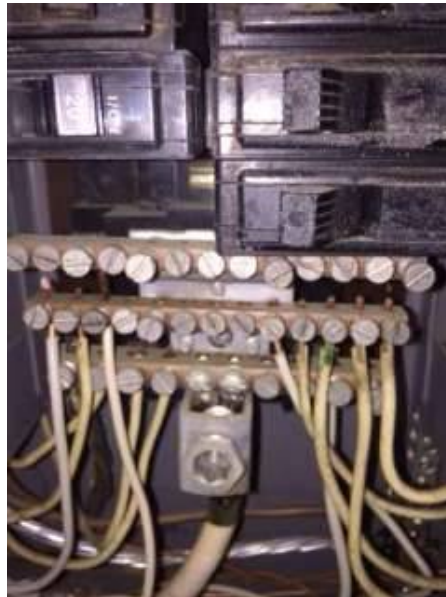
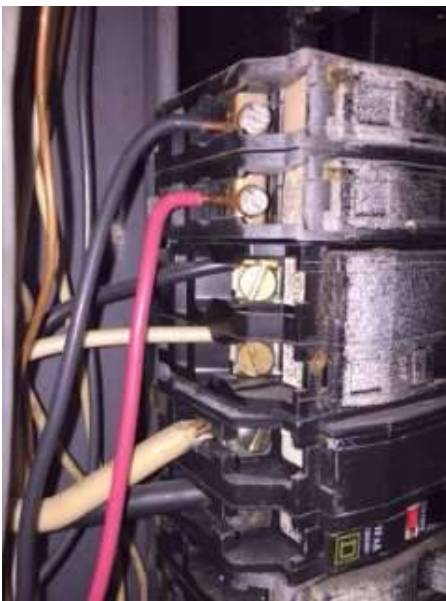
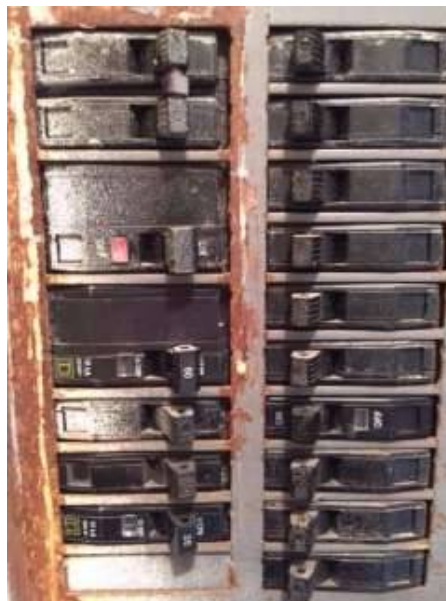
Views of Service Panel - Potential Double Tap which should be evaluated by a licensed professional - Outside of that appeared serviceable and in working order with minor wall damage at top of panel on wall.

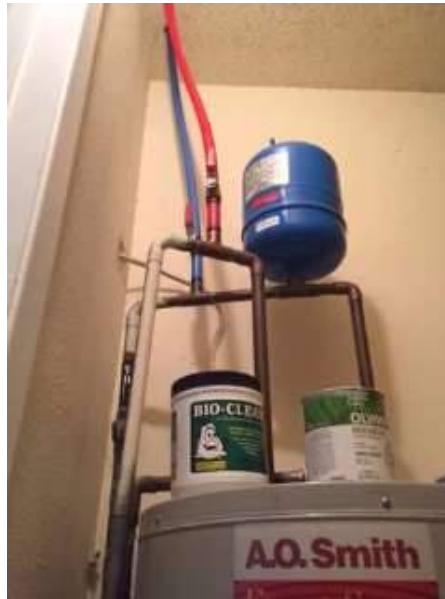
Photo 12-2
Expansion Tank - Water Heater.

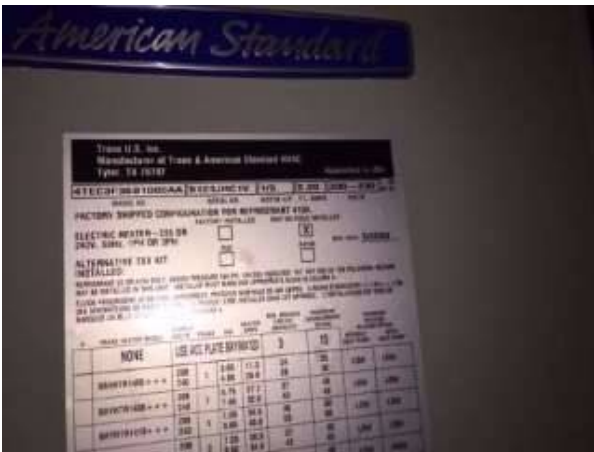
15) When inspected The AC/Heating appliances they appeared serviceable and in good working order. The condenser unit was manufactured in June 2009 and is a 3 ton unit and the air handler was manufactured in March of 2009 both American Standard. When tested the cold air return registered at 42 degrees with thermostat adjusted to 60 which is well within the 14-20 degree recommended range.

Photo 15-1
Manufacturers information on Air Handler in Attic.
March 2009

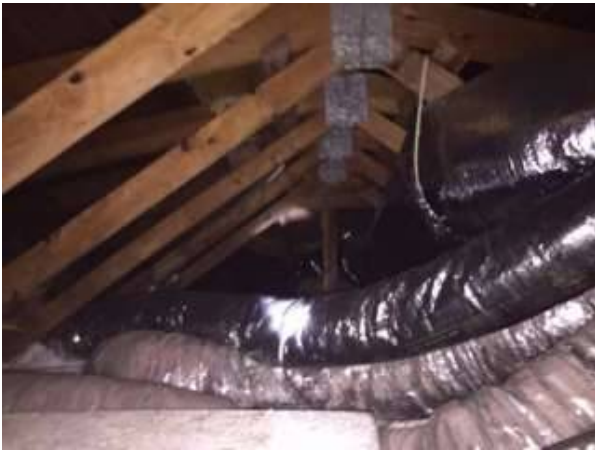
Photo X-5
View of attic duct work in working order.

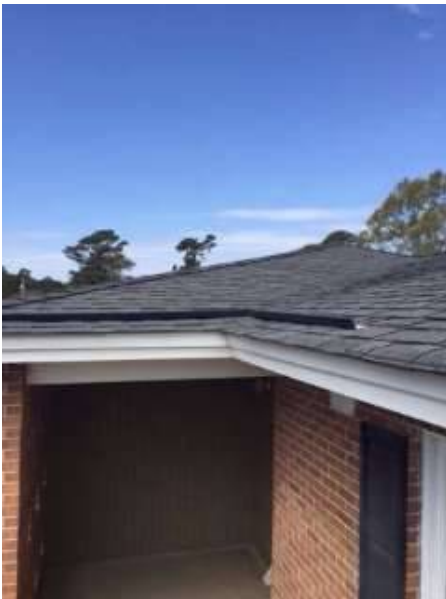
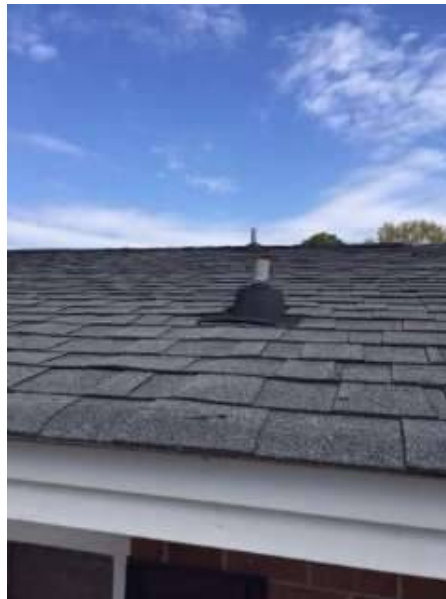
Photo X-15
View of Roof - In working order and serviceable.

Photo X-16
View of Roof - In working order and serviceable.

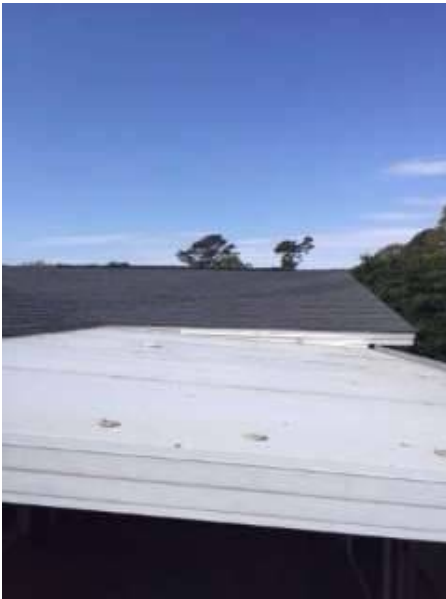
Photo X-17
View of Vinyl Roof Covering Back Porch-
In working order and serviceable.

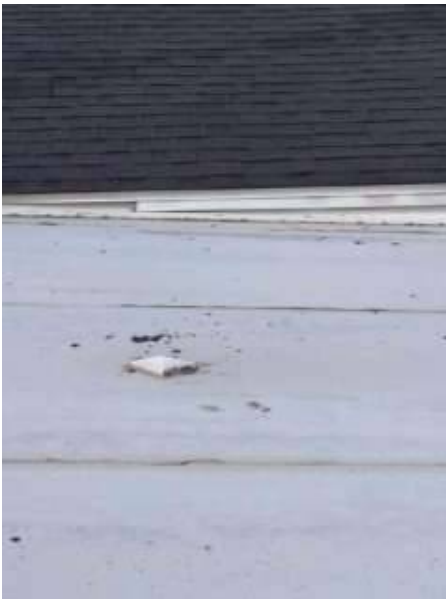
Photo X-18
View of Vinyl Roof Covering Back Porch-
In working order and serviceable.

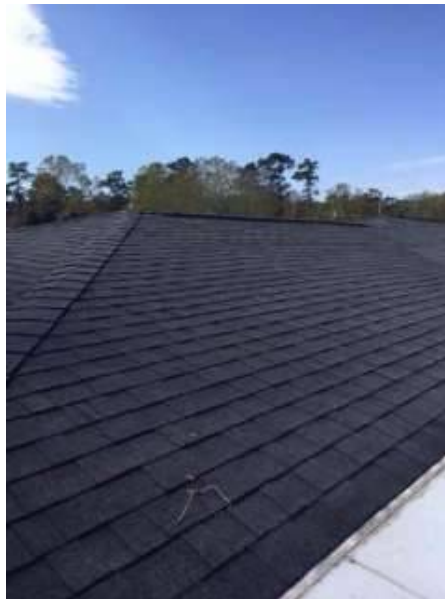
Photo X-19
View of Vinyl Roof Covering Back Porch-
In working order and serviceable.
