Grand Strand Inspections

Property Inspection Report

**Property address: 123 Melody Lane
Mayberry USA**

Inspection date: Thursday, March 17, 2016

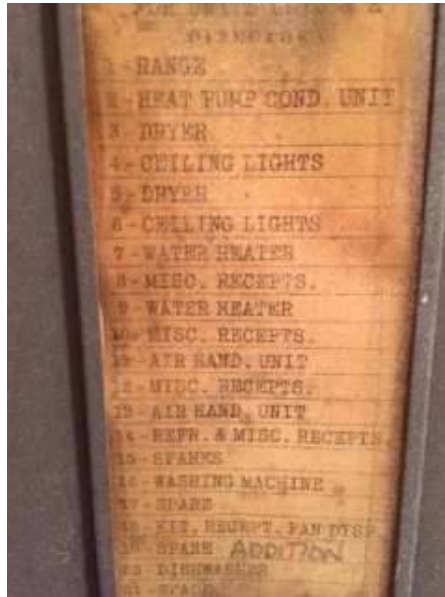
Views of Service Panel - Potential Double Tap which should be evaluated by a licensed professional - Outside of that appeared serviceable and in working order with minor wall damage at top of panel on wall.

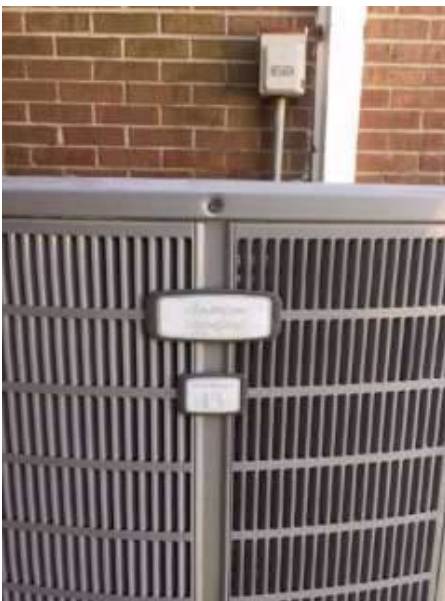
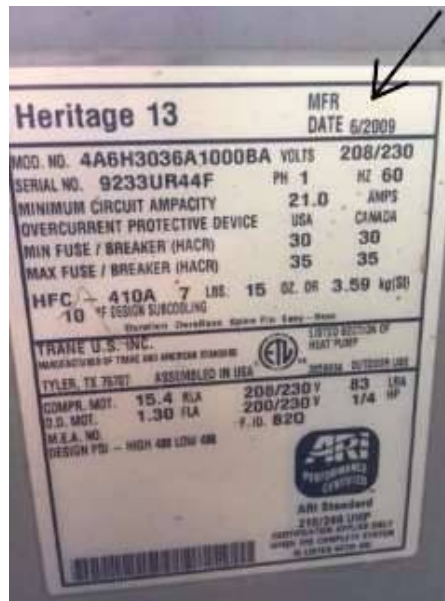
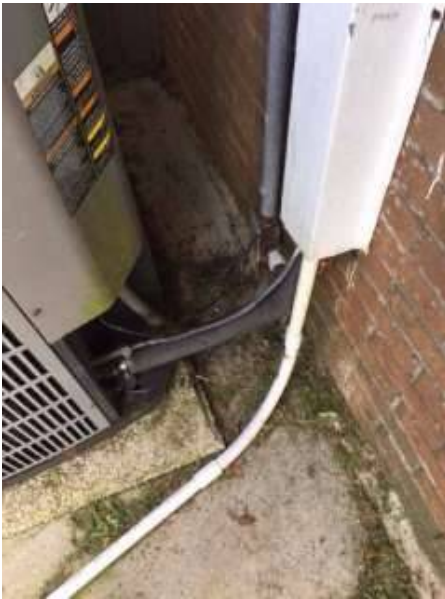
AC Condenser - American Standard -
Manufacture Date June 2009 - 3 Ton Unit.

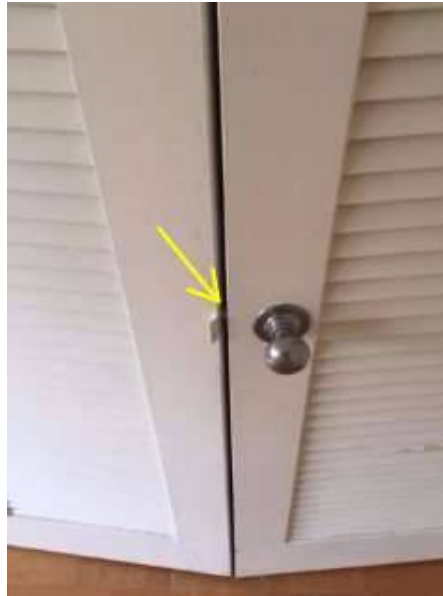
Photo 20-2

Not latching properly - Guest Bedroom.

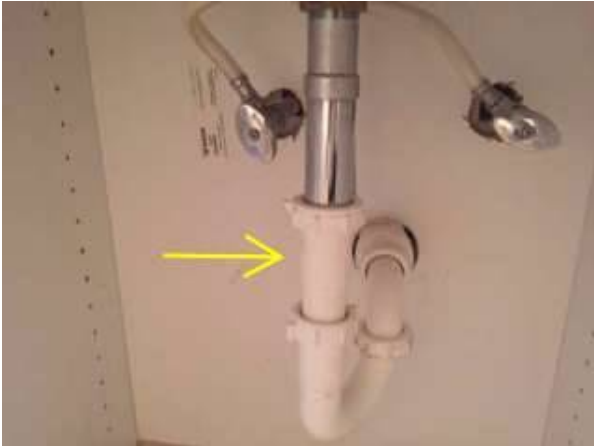
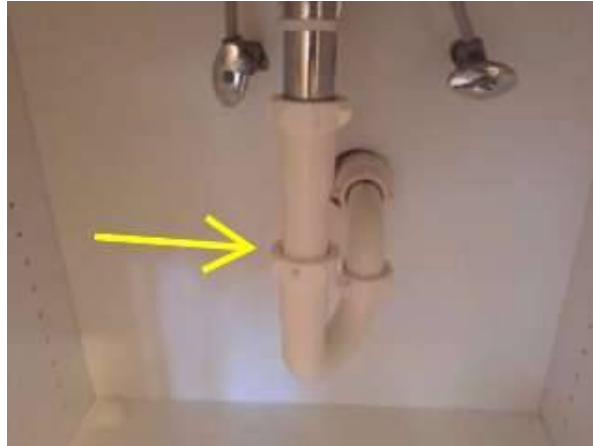
Photo X-1
Guest bath sink trap/drain in working order.

Photo X-2
Guest bath sink trap/drain in working order.
